# GE PGT10 PGT16

Advanced Repairs available only from Liburdi Turbine Services

## Liburdi Advanced Bucket Repairs for PGT10, PGT16

## Advanced Nozzle and Combustor Repairs for PGT10, PGT16

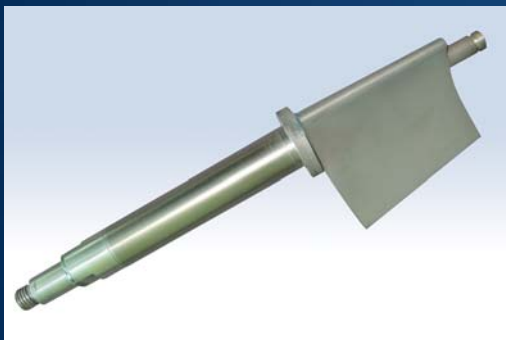
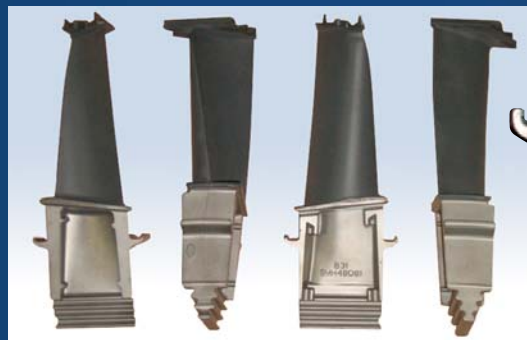
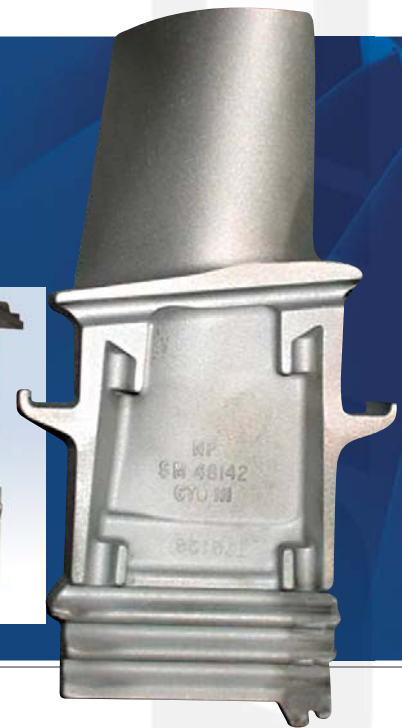
### Stage 1 Turbine Bucket Repairs and Upgrades

- Full coating strip and replace with oxidation/corrosion resistant Platinum Aluminide coatings
- FSR® Full Solution Rejuvenation® heat treatment process to fully restore alloy strength
- Bucket tip repairs with special oxidation resistant weld alloy

### Stage 2 Turbine Bucket Repairs and Upgrades

- Full coating strip and replace with oxidation/corrosion resistant Platinum Aluminide coatings
- FSR® Full Solution Rejuvenation® heat treatment process to fully restore alloy strength
- Bucket shroud z-notch restored with hardface weld alloy
- Shroud lift repaired to restore shroud alignment and engagement

### Stage 3, 4 Turbine Bucket Repairs and Upgrades

- Full coating strip and replace with oxidation/corrosion resistant Aluminide coatings
- FSR® Full Solution Rejuvenation® heat treatment process to fully restore alloy strength
- Bucket shroud z-notch restored with hardface weld alloy

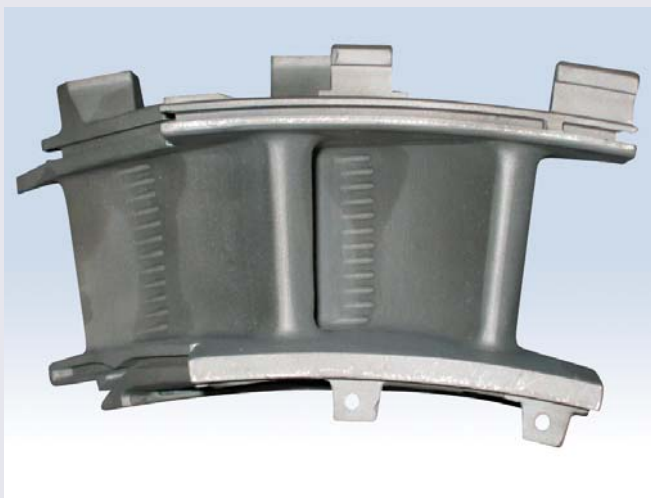
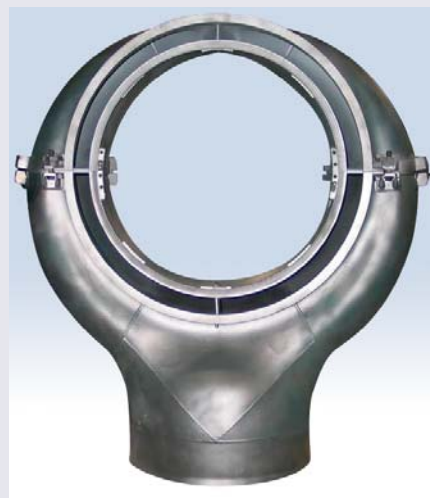
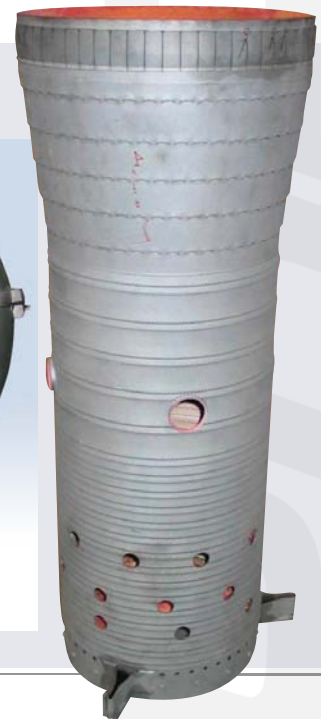
### Turbine Nozzle Repairs and Upgrades

- Full coating strip and replace with upgraded oxidation/corrosion resistant coatings
- Proprietary LPM® high strength powder metallurgy process used to repair crack damage.
- LPM® repair materials are higher strength than the original casting material and outperform conventional weld repairs
- LPM® to restore airfoil thickness and dimensions – not possible with conventional weld repairs

### Combustor Repairs and Upgrades

- Full strip and replacement of all coatings
- Combustor Liners receive matching strength weld repair of crack damage
- Transition Piece Upgrade includes enhanced impingement cooling design, reinforced walls, full Thermal Barrier Coating (replaces the original partial coating), and diffusion aluminide coating of external walls - to prevent future wall thinning and distortion.

**LPM® Powder Metallurgy** is a unique process developed and patented by Liburdi Engineering Limited. It is a high strength superalloy alternative to welding and diffusion brazing, and as such has been used extensively with a proven track record for over a decade for Industrial and Aircraft gas turbine components - for both advanced repairs and new part manufacturing. LPM® re-construction techniques strengthen critical high stress areas, and permit precise control when restoring airfoil wall thickness and throat area harmonics.
